Unsafe Aftermarket Steering Columns

Introduction:

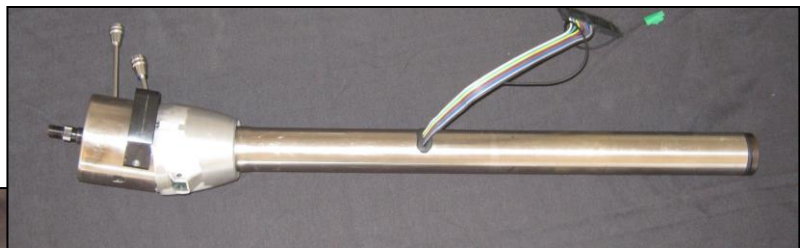
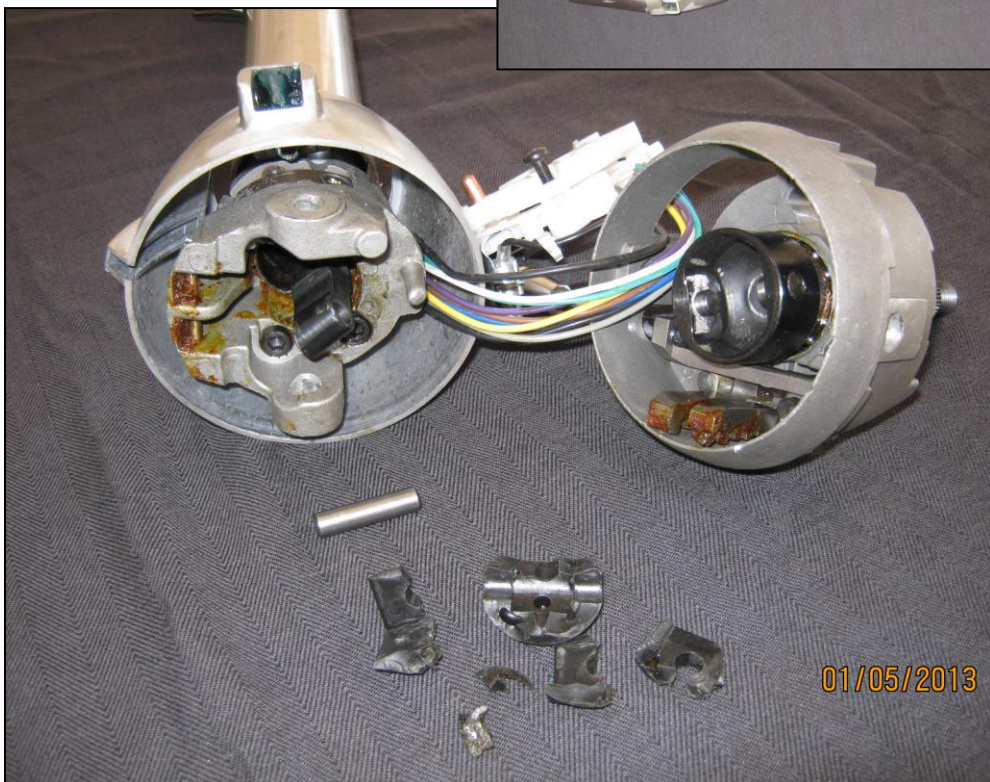
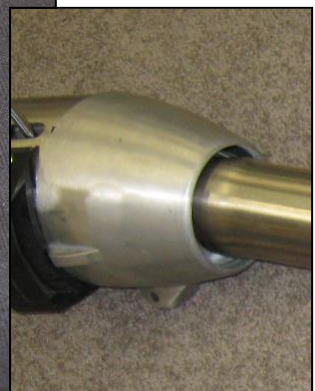
Figure 1: ‘Helix’ brand column, with collapsed plastic tilt mechanism

Figure 1 shows the failed tilt mechanism, which relied entirely on a poorly-moulded plastic bush, and two steel connection pins of inadequate length.

Aside from using poor-quality plastic in the bush – which is what failed in this case – the basic design is not ‘fail-safe’, and a complete loss of steering control is possible.

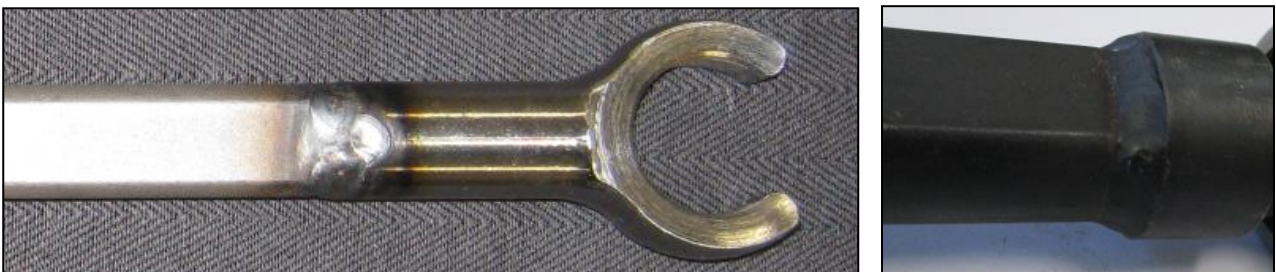
Figure 4: Non-OEM welds within tilt mechanisms in aftermarket steering columns

Any such welds in any aftermarket steering column (other than within one of the three recognised manufacturers' columns which include welding within their manufacturing process) must never be accepted for LVV certification.

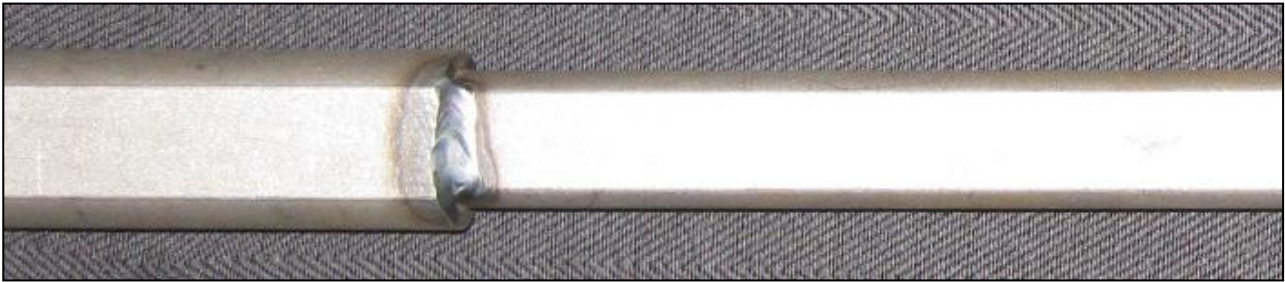
Figure 5: Welding holding two 'double-D' sections together within aftermarket steering column

This welding can be accepted on any column regardless of brand, as the vehicles' directional control does not rely on the weld.

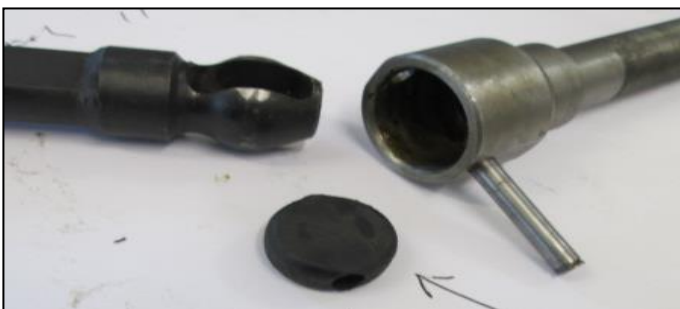
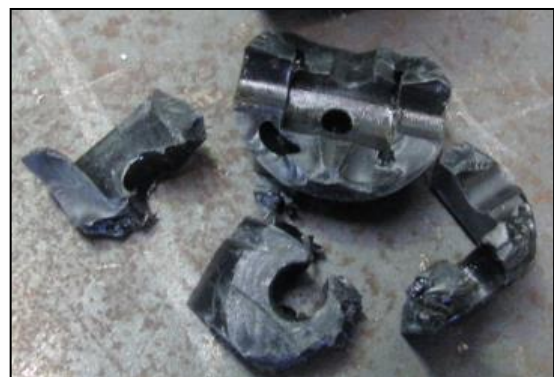
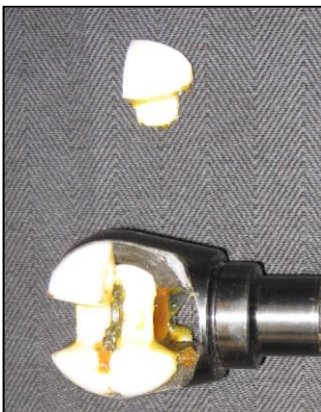
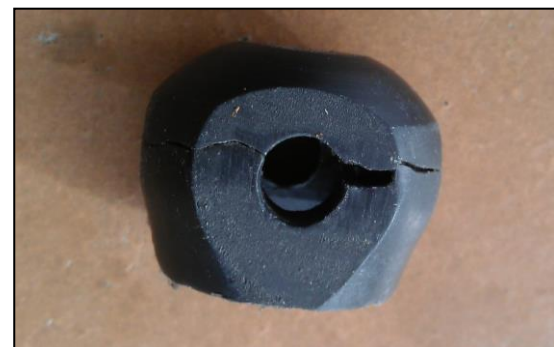
Figure 6: Various failed or excessively loose plastic bushes & balls within brand new aftermarket steering columns

Figure 6 shows some examples of plastic components that have broken, or have free-play when still brand new.

Above: Plastic swivel-joint bush with excessive play in brand new column.
 Above right: Failed plastic bush & pin system in brand new column.
 Right: Poorly-made injection-moulded plastic bush in brand new column.
 Left: Low-grade plastic tilt ball that fell apart during disassembly of tilt mechanism in brand new aftermarket GM-style column.

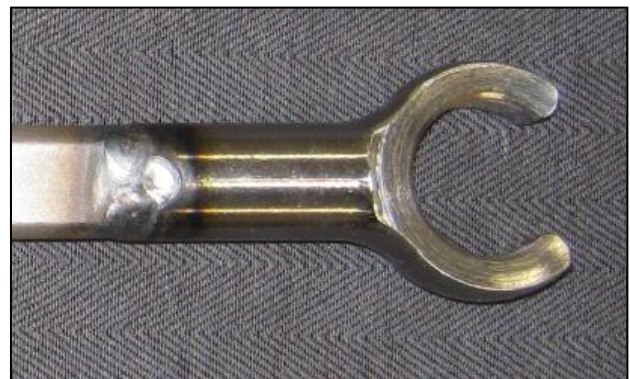
Figure 17: Welded ‘CPP’ yoke-to-shaft connection

The ‘CPP’ brand column incorporates a welded connection to join the lower yoke of the tilt mechanism to the main steering column shaft. Figure 17 shows a typical welded section from a ‘CPP’ brand tilt steering column, with a poor-quality weld. On other ‘CPP’ columns that LVVTA has inspected, this weld appears to simply butt-weld the two sections together (without the plug-weld that appears to exist in the example shown in Figure 16).

Column is to be rejected by LVV Certifier as unsafe. Upon vehicle owner's request, column may be disassembled and assessed by LVV Certifier for the purpose of visual comparison to that shown above. If verified as that shown above, column must be rejected. If internal components and systems fundamentally differ to that shown above, LVV Certifier should contact LVVTA technical staff for advice.

No approved repair process exists for this brand of steering column on a one-off basis.

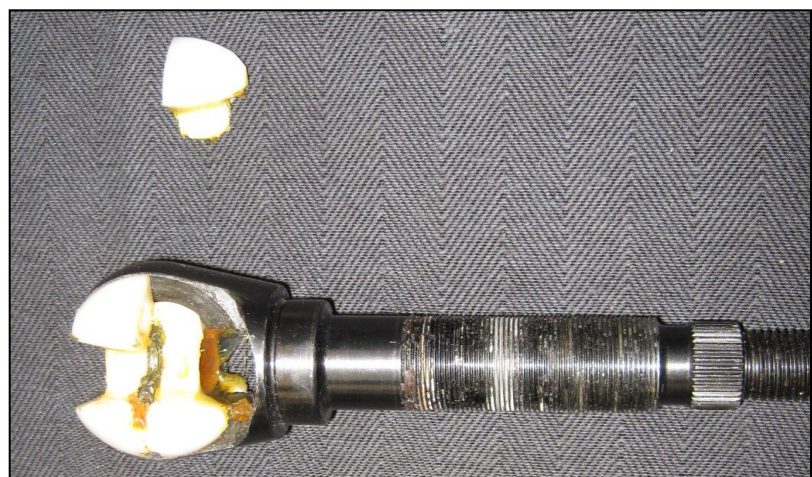
Figure 18: Plastic ball in unused ‘CPP’ column as found during disassembly

The tilt ball shown in Figure 18 with the corner piece broken away (shown as a separate piece at the top of photograph) was fractured in brand new unused condition, and fell apart during the disassembly process. No force was used to dismantle the mechanism.

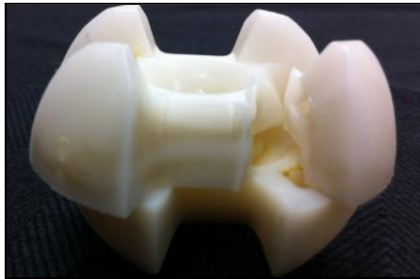
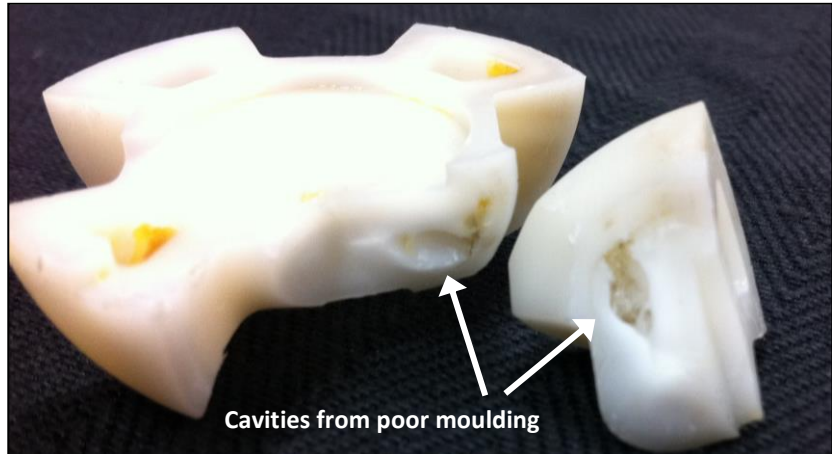
Figure 19: Injection-moulded plastic tilt-ball within brand new 'CPP' column, showing breakage and cavities

A further problem with the plastic tilt ball is that it has been manufactured via a very poor injection-moulding process that has left the tilt ball riddled with cavities and air pockets, as shown in Figure 19, which will assist in the collapse of the low-grade plastic ball under load. There is little likelihood that this tilt mechanism will be sufficiently strong and durable to withstand the high torque loads that will be imposed on it throughout its life, particularly in a vehicle without power steering.

When in position the ball looks normal, but where the ball has collapsed, cavities caused by a very poor moulding process which have massively weakened this critical plastic component are evident.

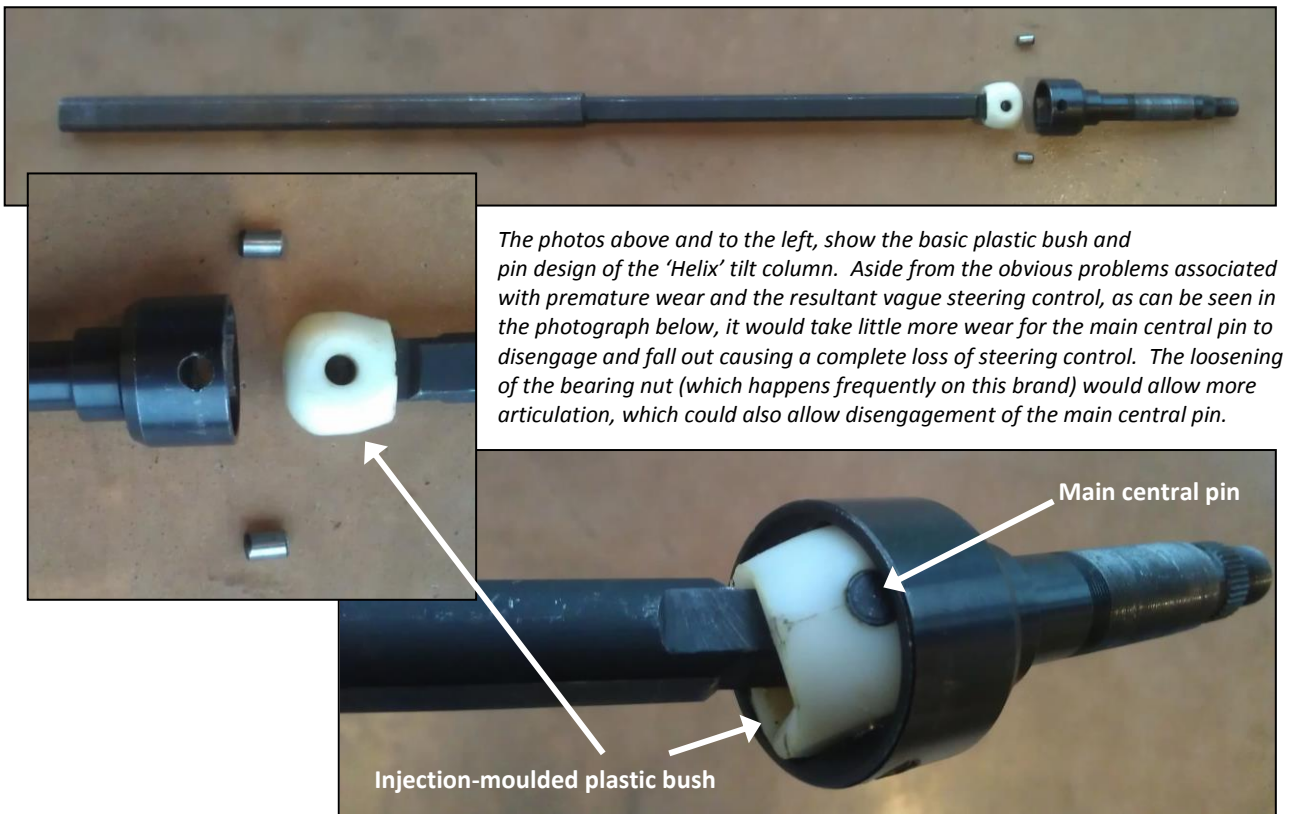
Figure 22: Plastic bush and pin design of the 'Helix' brand steering column tilt mechanism assembly

The group of photographs shown in Figure 22 below illustrate the plastic bush and pin system used in the 'Helix' brand as sold by the Hoffman Group. The 'Helix' system is a very rudimentary system, which is not 'fail-safe'. Due to the design of the tilt mechanism system and the poor quality of the components used, the 'Helix' system is considered by LVVTA to be of very poor design and quality, and the most dangerous system seen to date.

The tilt mechanism of the Chinese-made 'Helix' column shown in Figure 22 had so much play (without ever having been fitted to a vehicle) that it would have failed a warrant of fitness inspection.

Column is to be rejected by LVV Certifier as unsafe. Upon vehicle owner's request, column may be disassembled and assessed by LVV Certifier for the purpose of visual comparison to that shown above. If verified as that shown above, column must be rejected. If internal components and systems fundamentally differ to that shown above, LVV Certifier should contact LVVTA technical staff for advice.

No approved repair process exists for this brand of steering column on a one-off basis*.

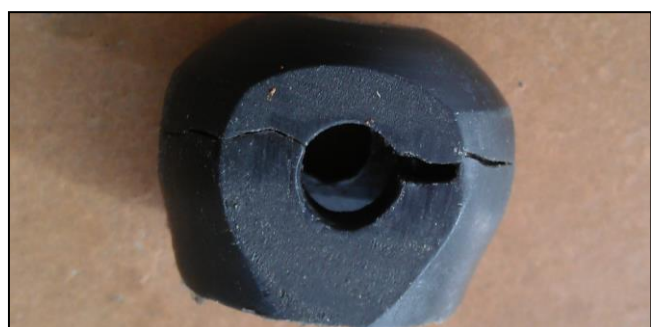
Figure 23: Poor-quality moulded bush with cavities & cracks

A further problem with this system, is that, aside from the overall poor design, one plastic bush (as shown in Figure 23) from this type of column that LVVTA inspected is so poorly moulded that – in brand new unused condition – was so full of casting flaws and cavities that it is likely to collapse with very little use. The column in which this bush was fitted, was reportedly sold as a 'Helix' brand but may in fact be of a different brand; - this identification problem is symptomatic of brand-copying and a lack of visual identifiers.

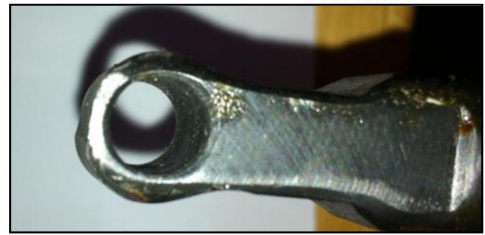
Figure 24: ‘Helix’ plastic bush pin-eye

The top end of the lower steering shaft is made from solid D-shape bar, which has been machined to create a pin-eye for the plastic bush to swivel from, as shown in Figure 24. Poor machining tolerances of that pin-eye lead to an inconsistent shape around the pin-eye opening, which in turn leads to a lack of uniformity and wall thickness in some areas of the pin-eye area. It is unlikely that sufficient quality control processes exist in order to ensure that the machining process involved is consistent and repeatable.

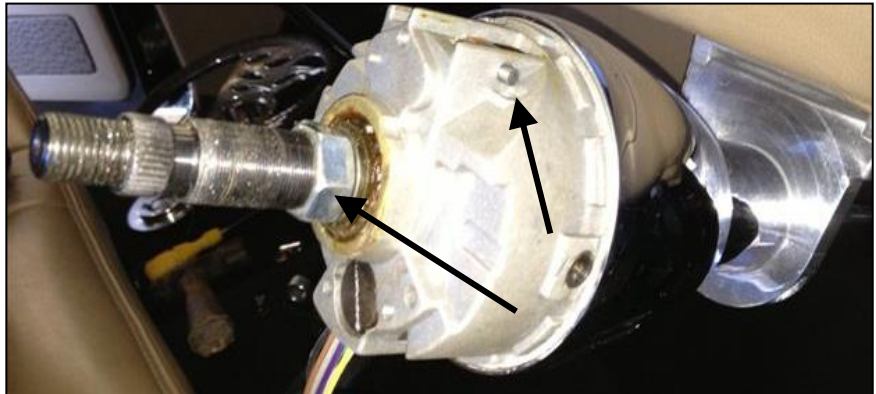
Figure 25: Main retaining nut with no locking system in ‘Helix’ column

Some ‘Helix’ columns have, from brand new, a huge amount of free-play, both up and down, and side-to-side. The reason for the play is that the main nut used to retain the upper steering shaft into the upper bearing housing (see Figure 25) had completely loosened itself off. This occurs because there is no locking mechanism to prevent it from undoing, which is poor design, and process control.

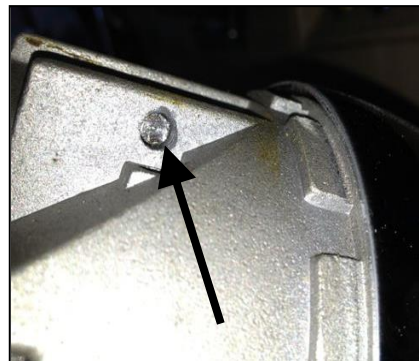
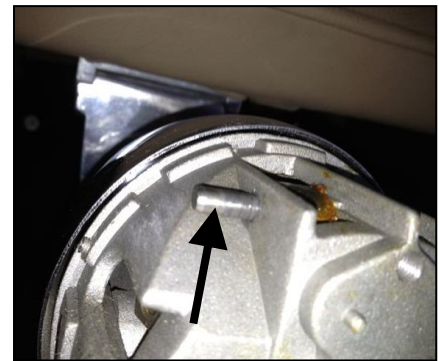
Figure 26: Tilt mechanism pivot lock pin falling out of ‘Helix’ upper housing

Additionally, the removal of the steering wheel and upper steering column components to enable the inspection for the play at the upper housing also showed that the tilt mechanism pivot lock pin (see arrows in Figure 26) for the tilt mechanism had almost completely fallen out. Again, there was no locking mechanism to prevent it from doing so.

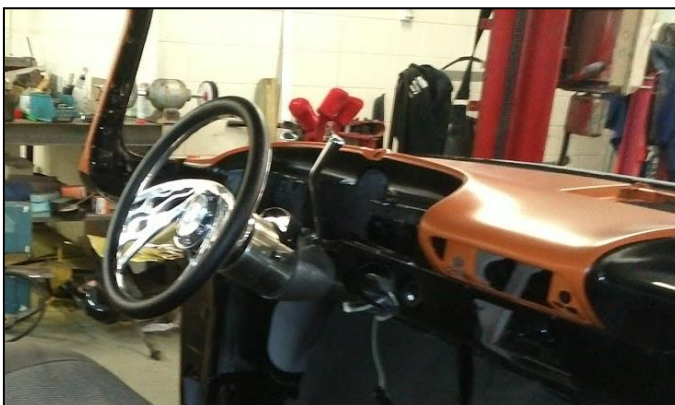
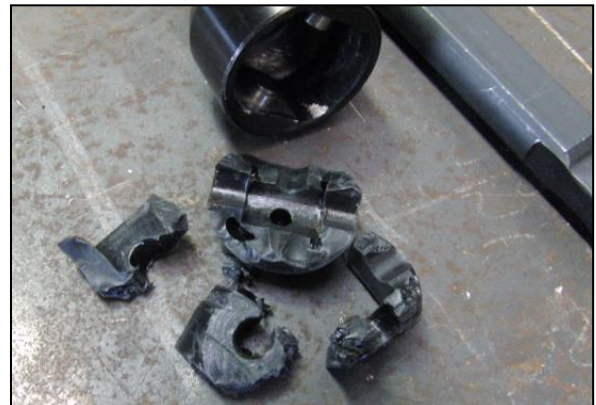
Figure 27: ‘Helix’ column in vehicle at left; collapsed remains of the plastic bush which caused steering failure at right

Underlining how poorly-designed and unsafe the ‘Helix’ steering column is, one such column completely failed leaving the driver totally without any directional control of his vehicle. The principal failure was the poor-quality plastic bush described previously, however, the fact that the basic system is not ‘fail-safe’ turned a tilt mechanism component failure into a complete steering system failure. See Figure 27.

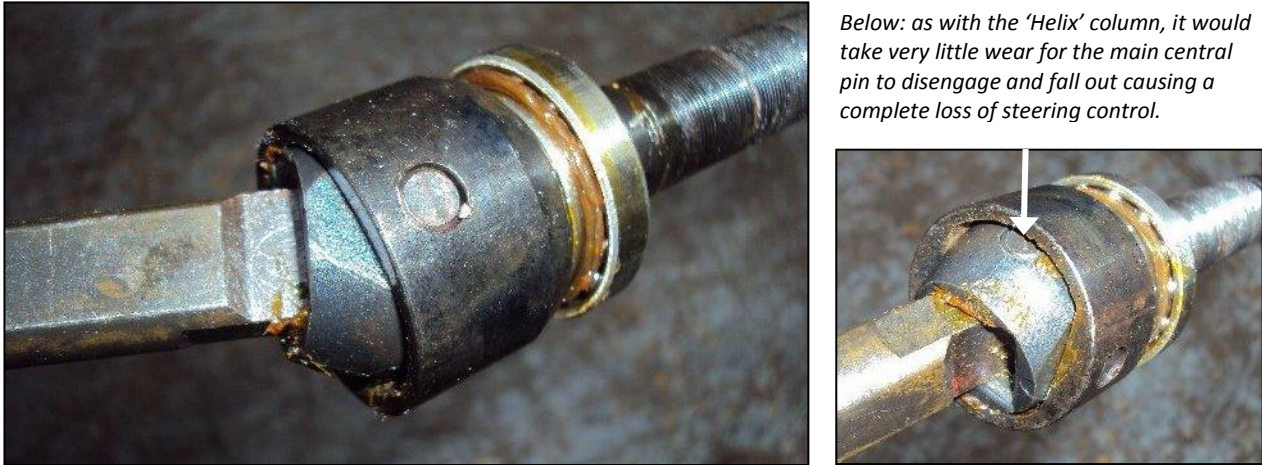
The photographs shown in Figure 29 below illustrate the same plastic bush and pin system as used in the 'Helix' brand, which failed and caused a complete loss of steering control. The 'Procomp' system is, like the 'Helix' column, a very rudimentary system, which is not 'fail-safe'. Due to the design of the tilt mechanism system and the poor quality of the components used, in particular the injection-moulded plastic bush (upon which the entire directional control of the vehicle relies), the 'Procomp' system is considered by LVVTA to be of extremely poor design and quality, and may be just as dangerous as the 'Helix' brand steering columns.

Below: as with the 'Helix' column, it would take very little wear for the main central pin to disengage and fall out causing a complete loss of steering control.

Particularly because of the plastic bush and pin system within the tilt mechanism, there is nothing that LVVTA is aware of to prevent a 'Procomp' brand column having the same complete and catastrophic failure as experienced by the owner of the 'Helix' brand column depicted earlier in this Information Sheet.

Column is to be rejected by LVV Certifier as unsafe. Upon vehicle owner's request, column may be disassembled and assessed by LVV Certifier for the purpose of visual comparison to that shown above. If verified as that shown above, column must be rejected. If internal components and systems fundamentally differ to that shown above, LVV Certifier should contact LVVTA technical staff for advice.

No approved repair process exists for this brand of steering column on a one-off basis*.

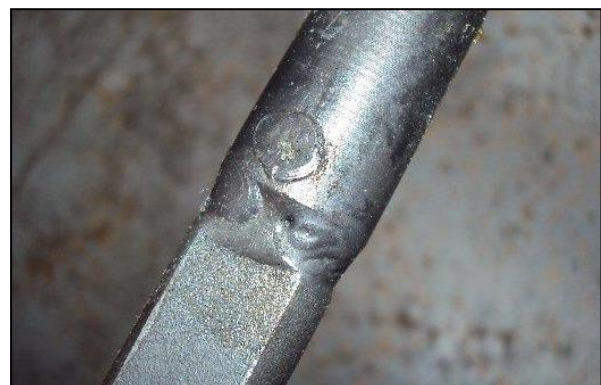
Figure 32: Welded connection in 'RPC' steering shaft

As can be seen in Figure 31 above, the 'RPC' brand column incorporates a welded connection to join the lower yoke of the tilt mechanism to the lower steering column shaft. Figure 32 shows a close-up image of the welded section from an 'RPC' brand tilt steering column, with an obvious defect visible within the photograph of the poor-quality weld. Despite the presence of a plug-weld, LVVTA cannot have any confidence in the quality controls of the welding, or the suitability in either the parent or filler materials used in the manufacturing and welding processes, particularly given that the entire directional control of the vehicle relies upon this weld.

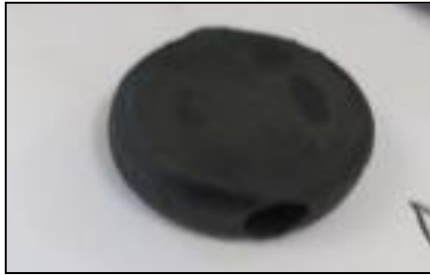
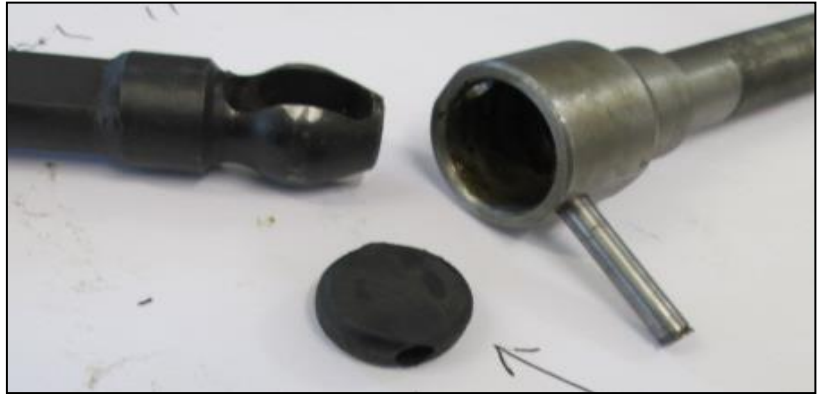
Figure 34: Poor-quality injection-moulded plastic tilt-disc on 'Wysco' column

'Wysco' brand steering columns use a swivel joint system (as shown in Figure 34) which appears to be a poorly-designed copy of the 'Flaming River' system, but instead of using a brass tilt-disc to allow rotation between the two shaft sections, it incorporates a poor-quality plastic bush which, in brand new unused condition, during LVVTA's inspection of one such unit, had so much play that it would have failed a warrant of fitness inspection.

Although difficult to tell in the photos, the plastic bush was full of cavities as a result of a poor injection-moulding process.

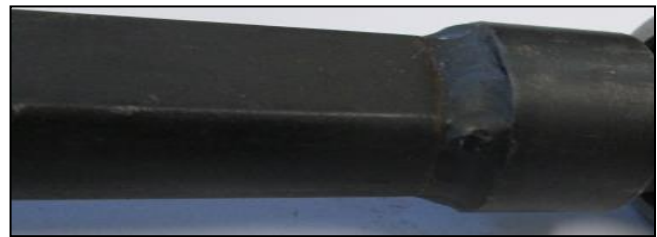
Figure 35: Welded shaft connection on 'Wysco' column

The 'Wysco' brand aftermarket steering column incorporates a welded connection of unknown and unverified quality to join the tilt-ball housing of the tilt mechanism to the main lower steering column shaft. Figure 35 shows a welded connection, joining the swivel-joint housing to the lower shaft within a 'Wysco' brand tilt steering column – upon which the entire directional control of the vehicle relies.

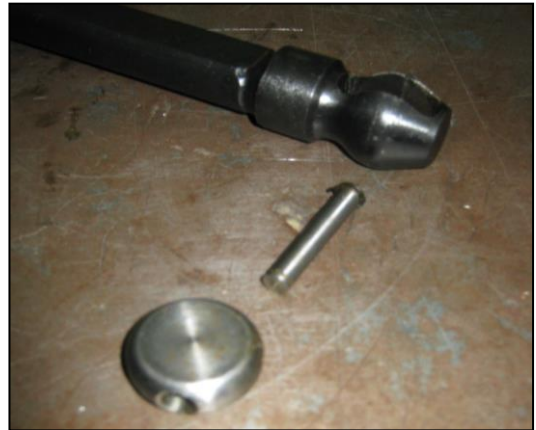
Figure 36: 'Unknown brand A' swivel-joint

As shown in Figure 36, unlike the 'Wysco' brand steering column which featured an injection-moulded plastic tilt-ball, the tilt-ball within the 'Unknown brand A' swivel joint housing is made from steel. While this will have the required strength properties, there will, over time be binding and wearing problems that result from the steel tilt-ball's inability to self-lubricate.

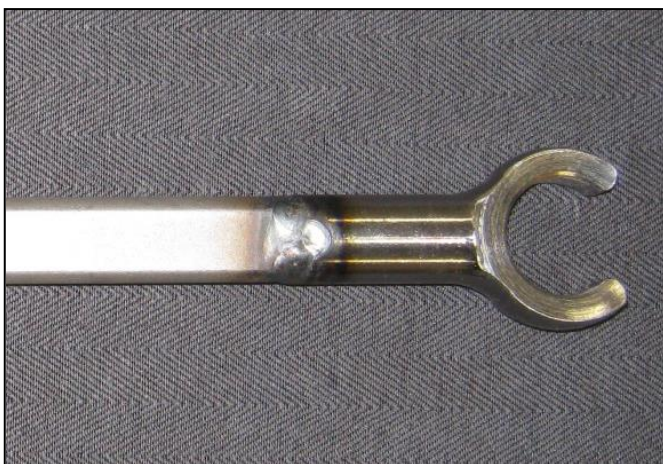
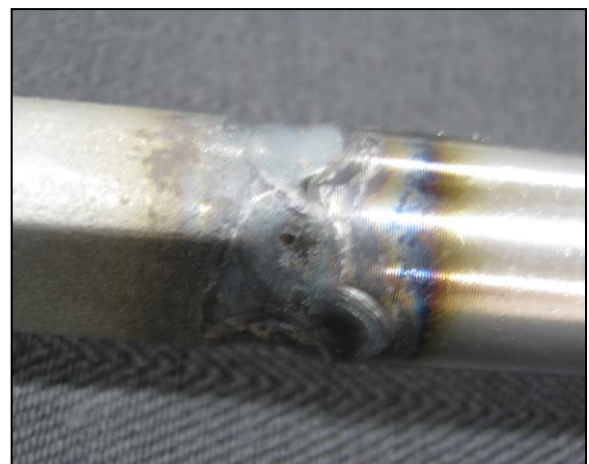
Figure 37: 'Unknown brand B' with GM-style 'double yoke' tilt mechanism, and poor-quality welded connection

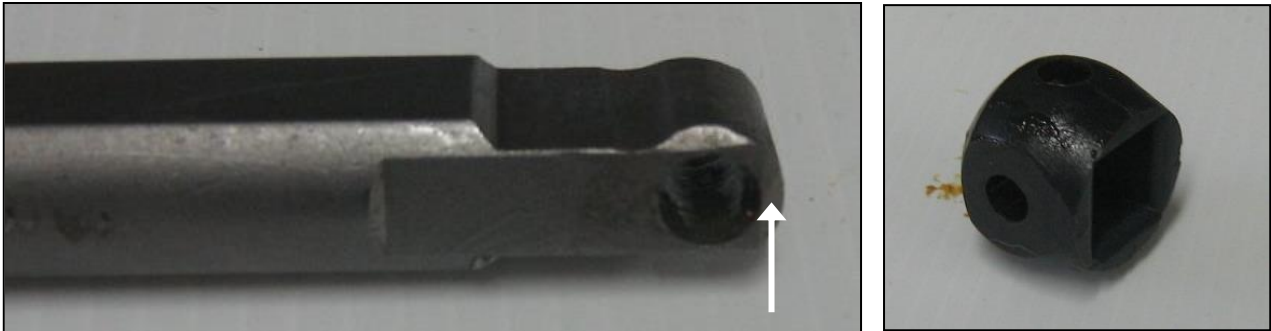
Figure 38: 'Unknown brand C' with unsafe plastic bush and pin system, & inconsistent forming of bush pin-eye
