Unsafe Aftermarket Steering Columns

Introduction:

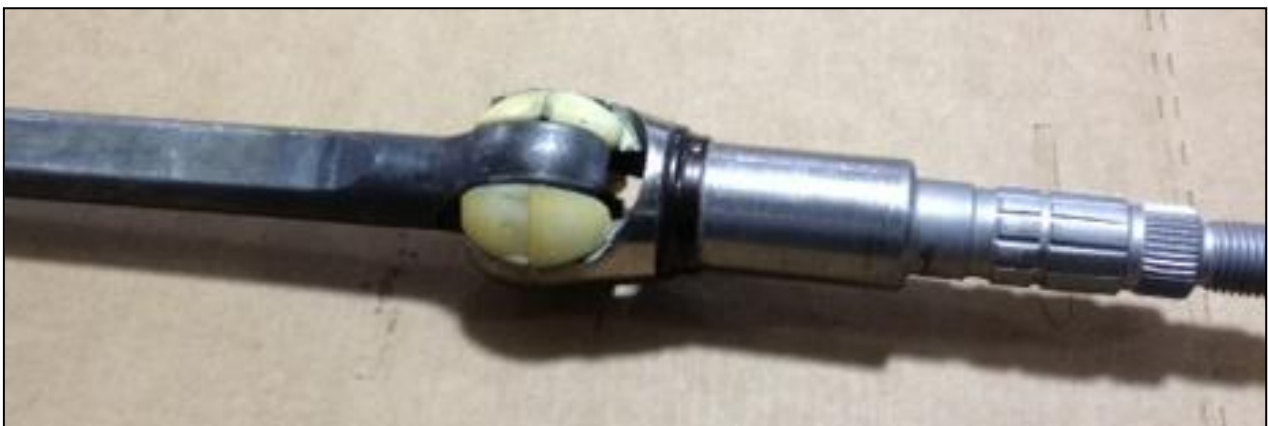
Figure 2: 'GM-style' tilt mechanism assembly, featuring upper and lower yoke shafts

Figure 2 shows a connection system which looks like a miniature constant velocity joint that is, or replicates, the OEM system used by General Motors in their tilt columns, which cannot disconnect within the column housing (the two sections have to be turned at 90 degrees to each other before they can be disconnected, which obviously cannot occur within the column housing). This system is used by most reputable brands.

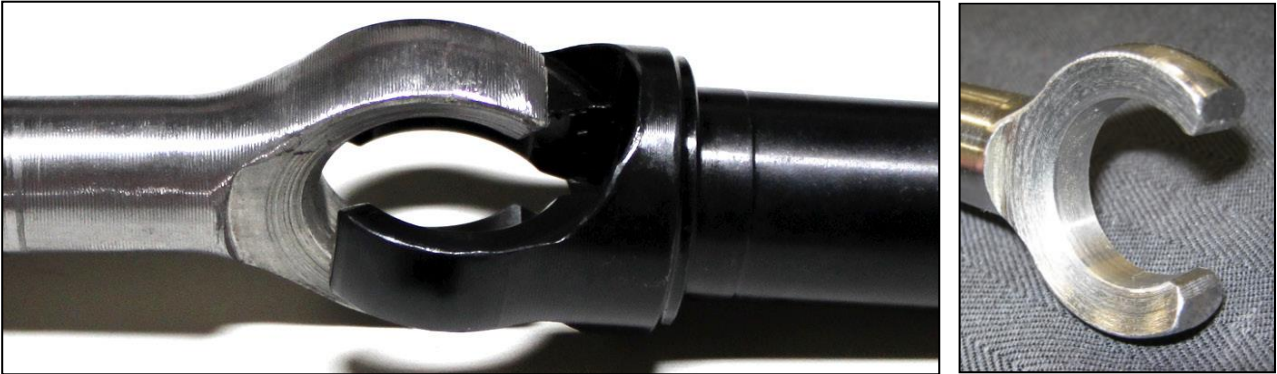
Figure 3: Two 'yokes' of the 'GM-style' tilt mechanism with bush removed, showing 'fail-safe' nature of system

As a general sound engineering principle associated with tilt steering columns, any tilt mechanism should be 'fail-safe', meaning that if any component within the tilt mechanism - such as the tilt ball, shaft, or pin – should for some reason fail, the two forks at each end of the shaft sections (in the case of the GM system) will still remain connected and 'drive'. Even with the plastic tilt-ball completely removed from the GM system, the two yokes will still remain engaged and drive, albeit with approximately 1/8th of a turn of free-play. See Figure 3.

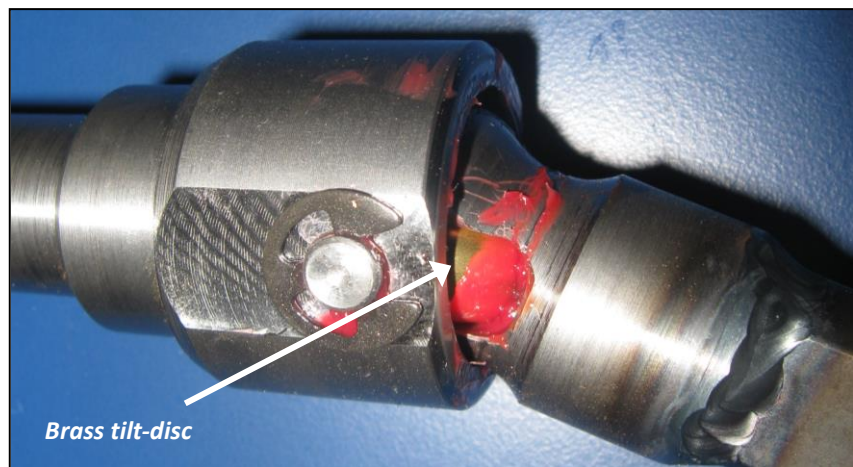
Figure 8: 'Flaming River' brand swivel-joint tilt mechanism assembly.

'Flaming River' uses a 'swivel-joint' tilt mechanism. Although not a proper automotive CV-like joint (as used by 'Ididit' and 'Billet Specialties') it nevertheless appears to be a robust system, and LVVTA has never heard of any problems with this system. An important part of this system is that it uses a proper brass disc-shaped bush as shown in Figure 8, as opposed to the inferior and cheaper plastic bush used by one of the cheap Asian copies.

'Flaming River' incorporates a welded connection at the upper end of the lower steering shaft as shown in Figure 8. 'Flaming River' has confirmed that it uses only TIG-welding, the welds have been tested by an external accredited laboratory, and an on-going quality control system is in place to ensure consistency and repeatability.

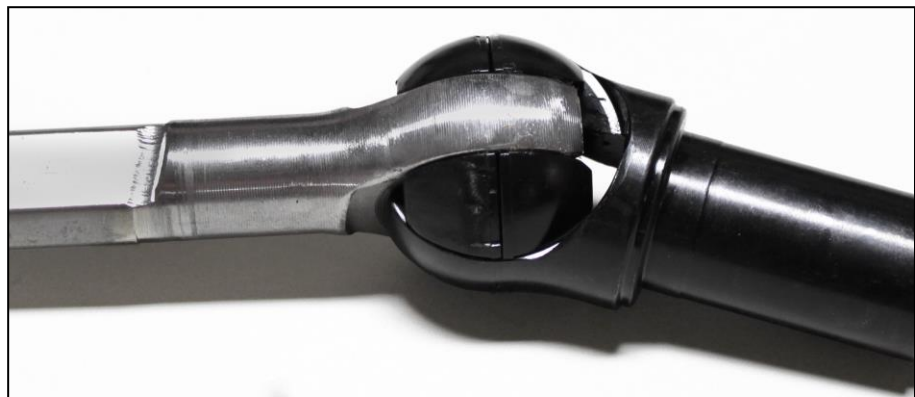
Figure 10: 'Ididit' remanufactured GM-style tilt mechanism & inertia-welded shaft

'Ididit' use a 'fail-safe' remanufactured GM-style tilt mechanism as shown in Figure 10. 'Ididit' have confirmed that all of the critical components used in the manufacture of their mechanisms are made by ISO-accredited facilities, and the captured tilt ball within the joint is a high-quality acetal copolymer, a material designed for high-load applications.

'Ididit' incorporates a weld connecting one 'yoke' to the lower shaft (as seen in Figure 10).

The welding process, which is carried out by an independently certified specialist, uses an inertia welding system which penetrates a controlled amount of depth and uses only the parent material.

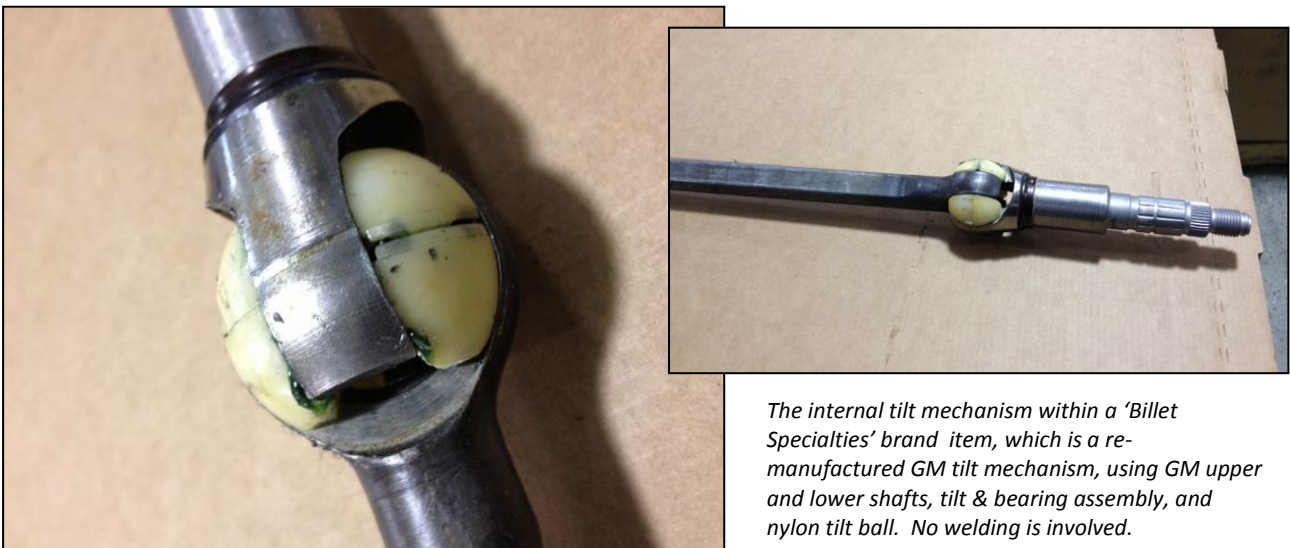
Figure 12: GM-style constant-velocity joint tilt mechanism assembly within ‘Billet Specialties’ column

From LVVTA’s research to date, ‘Billet Specialties’ – as shown in Figure 12 - is the only aftermarket column manufacturer who uses all remanufactured GM components internally and are assembled without any welding.

The internal tilt mechanism within a ‘Billet Specialties’ brand item, which is a re-manufactured GM tilt mechanism, using GM upper and lower shafts, tilt & bearing assembly, and nylon tilt ball. No welding is involved.

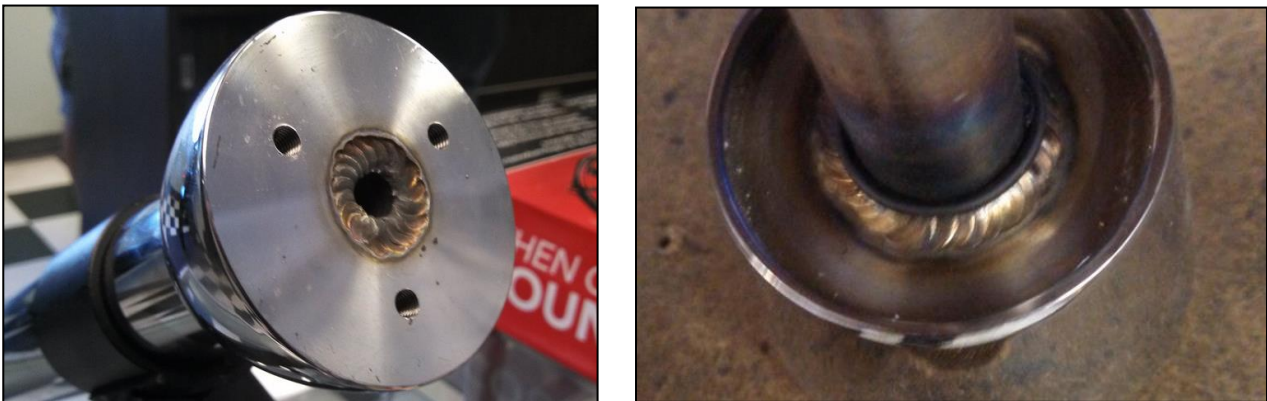
Figure 13: 'Limeworks' new-version 'Hot Rod'-style column at left, and old-version 'Hot Rod'-style column at right

'Limeworks' do not manufacture an aftermarket tilt steering column, so the only issue associated with this brand is their welding at the top end of the column. The 'Limeworks' traditional old Ford-style columns known as the 'Banjo' style and the 'Forty' style do not incorporate any welding anywhere, whereas their straight 'Hot rod' style columns (as shown in Figure 13) for use with three and four-spoke steering wheels are welded at the steering column head. 'Limeworks' old -version 'Hot Rod'-style column is welded on the underside of the steering wheel hub, and the new-version 'Hot Rod'-style column is welded on the top-side of the steering wheel hub.

'Limeworks' is a small California-based specialist fabrication shop, and all welding is carried out by one of two highly skilled welders on-site. The company has a long-standing and good reputation for high-quality products.

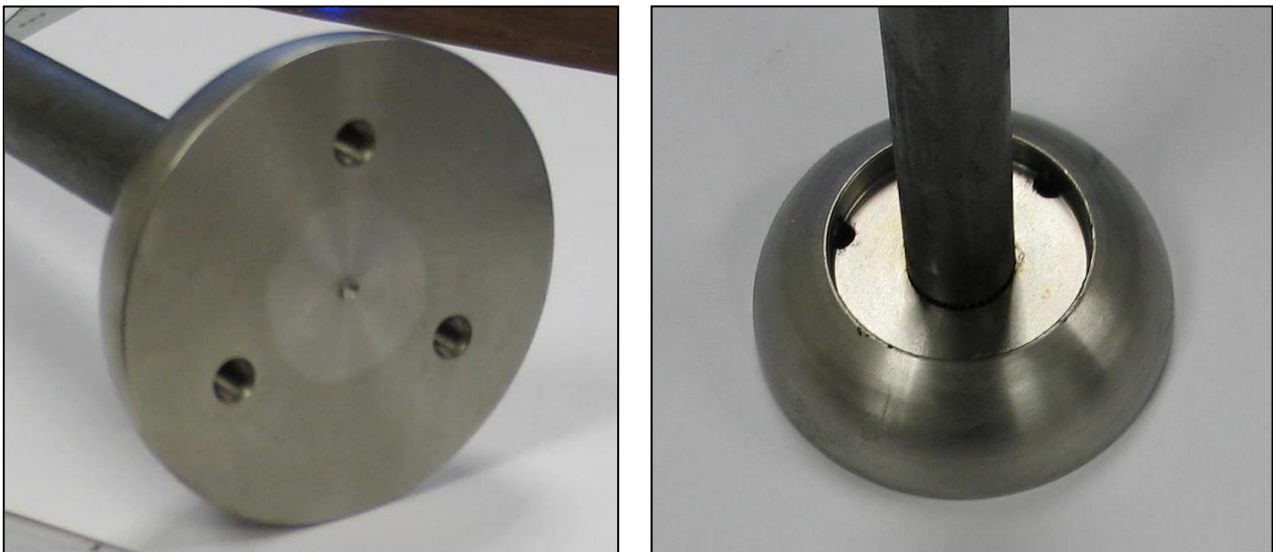
Figure 14: Welded and machined steering wheel hub face on left; back-side of steering wheel hub on right

While LVVTA holds the Borgeson company in high regard as a component manufacturer in general terms, LVVTA has a concern with this particular connection system, in that the welded steering wheel hub assembly is machined smooth (as shown in the photo to the left of Figure 14) removing most of the weld, and there is no welding on the back -side (as shown in the photo to the right of Figure 14) as a safeguard against the potential for the weld to be 'over-machined'. This is poor engineering practice. The position of the top bearing will prevent an un-machined weld from being carried out on the back-face of the hub.

In such a system, it is good practice to use a secondary securement method with the spline, so that the on-going rotational forces that the connection will be subjected to are not reliant entirely on a spline alone.

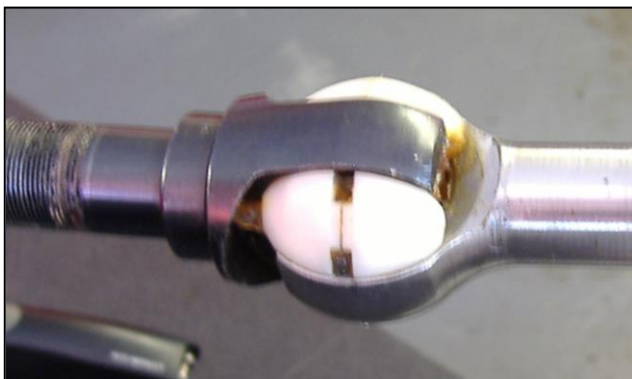
Figure 16: ‘CPP’ double-yoke tilt mechanism

The design of the tilt mechanism within the ‘CPP’ brand column is based on the GM-style double-yoke system (as shown in Figure 16), however the origin and quality of the ‘CPP’ mechanism is unknown, and therefore cannot be assured of being fit for use as a critical-function component such as a steering column. LVVTA believes that ‘CPP’ began manufacturing their own columns during 2012, and that the columns are manufactured in China.

The ‘CPP’ brand column incorporates a welded connection to join the lower yoke of the tilt mechanism to the main steering column shaft. Figure 17 shows a typical welded section from a ‘CPP’ brand tilt steering column, with a poor-quality weld. On other ‘CPP’ columns that LVVTA has inspected, this weld appears to simply butt-weld the two sections together (without the plug-weld that appears to exist in the example shown in Figure 16).

Column is to be rejected by LVV Certifier as unsafe. Upon vehicle owner's request, column may be disassembled and assessed by LVV Certifier for the purpose of visual comparison to that shown above. If verified as that shown above, column must be rejected. If internal components and systems fundamentally differ to that shown above, LVV Certifier should contact LVVTA technical staff for advice.

No approved repair process exists for this brand of steering column on a one-off basis.

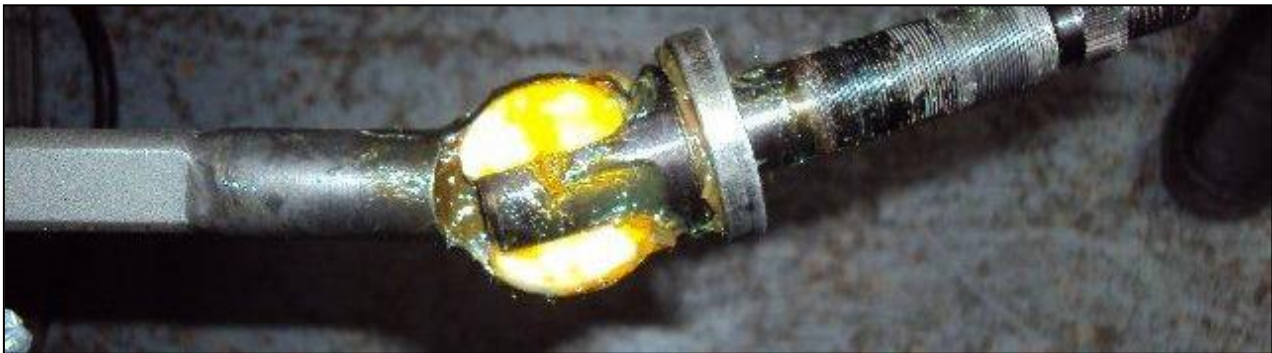
Figure 31: 'RPC' brand uses 'double-yoke' GM-style tilt mechanism

The design of the tilt mechanism within the 'RPC' brand column is based on the GM-style double-yoke system (as shown in Figure 31), however the origin and quality of the 'RPC' mechanism is unknown, and therefore cannot be assured of being fit for use as a critical-function component such as a steering column.

As can be seen in Figure 31 above, the 'RPC' brand column incorporates a welded connection to join the lower yoke of the tilt mechanism to the lower steering column shaft. Figure 32 shows a close-up image of the welded section from an 'RPC' brand tilt steering column, with an obvious defect visible within the photograph of the poor-quality weld. Despite the presence of a plug-weld, LVVTA cannot have any confidence in the quality controls of the welding, or the suitability in either the parent or filler materials used in the manufacturing and welding processes, particularly given that the entire directional control of the vehicle relies upon this weld.

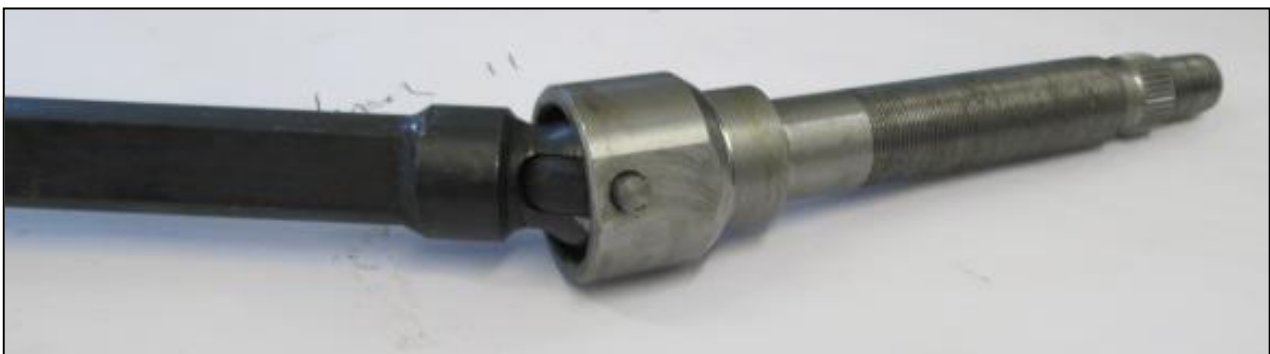
Figure 33: 'Wysco' column with a swivel-joint tilt mechanism

'Wysco' brand:**Identification:**
